WINFIELD LOCKS & DAM

Main Lock

Upper Miter Gate Repairs

February 10, 2016

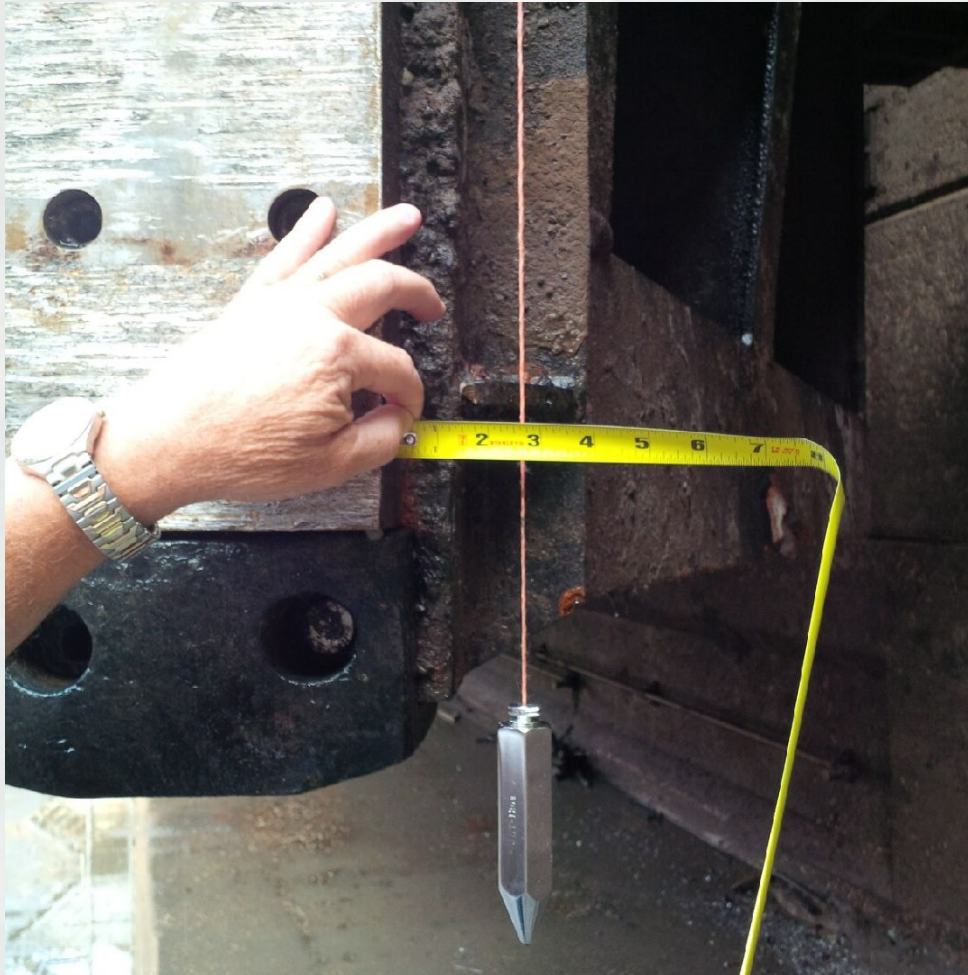
Gate out of Plumb
Almost 3 Inches

After removing miter
blocks and stressing
diagonals gates were
within $\frac{1}{4}$ " from top to bottom

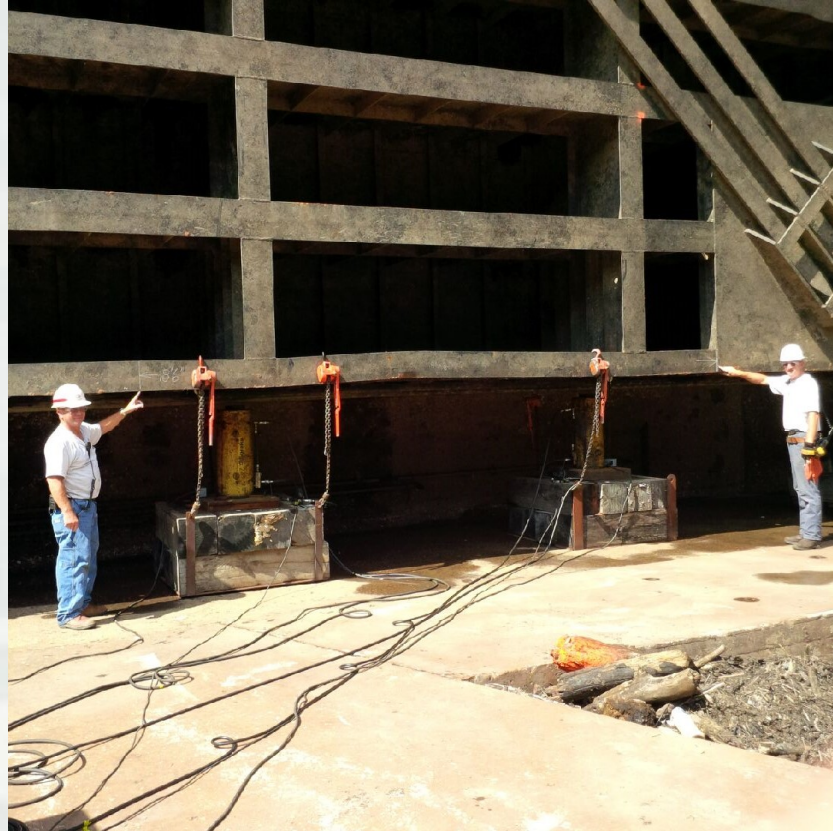
Buckled Bottom Girder on
Upper Land Wall Gate Showing
Section of Flange that was
Removed and Replaced

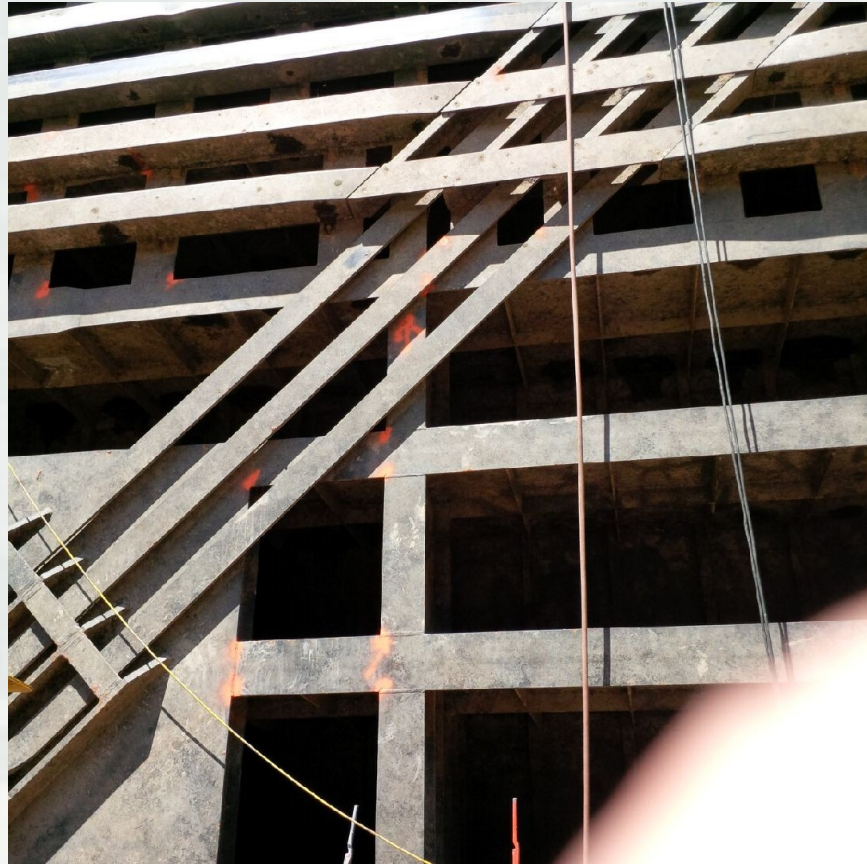
Discovered numerous cracks in both gates. These were ground out, welded and tested.
